Manhole Inspection Summary

Manhole # S37GG1017MH

Insp Date: **1/10/07 10:01 AM**

Location Address: **606 WYANOKE AVE**

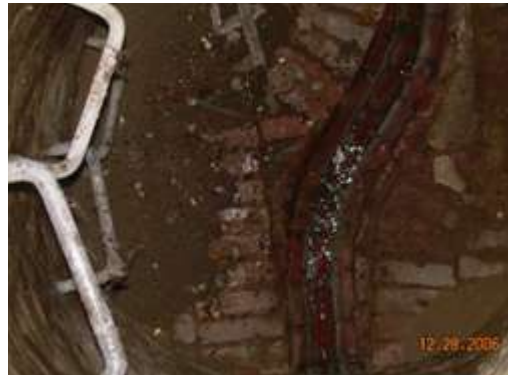
Top View

Evidence of surcharge - Bench debris.

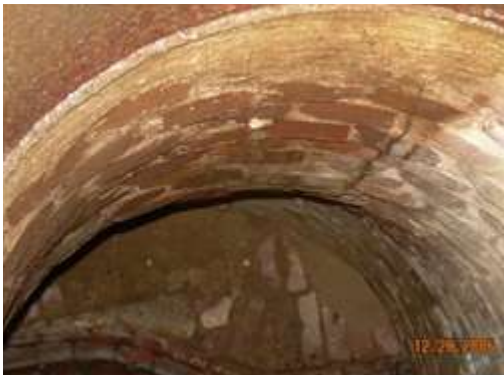
Defect

Frame leaks. Adjustment and Barrel infiltration.
